Natural resources and bioeconomy studies 45/2022

Stream restorations and their impacts for brown trout and salmon in FRESHABIT LIFE IP-projects

Mikko Hynninen and Teppo Vehanen

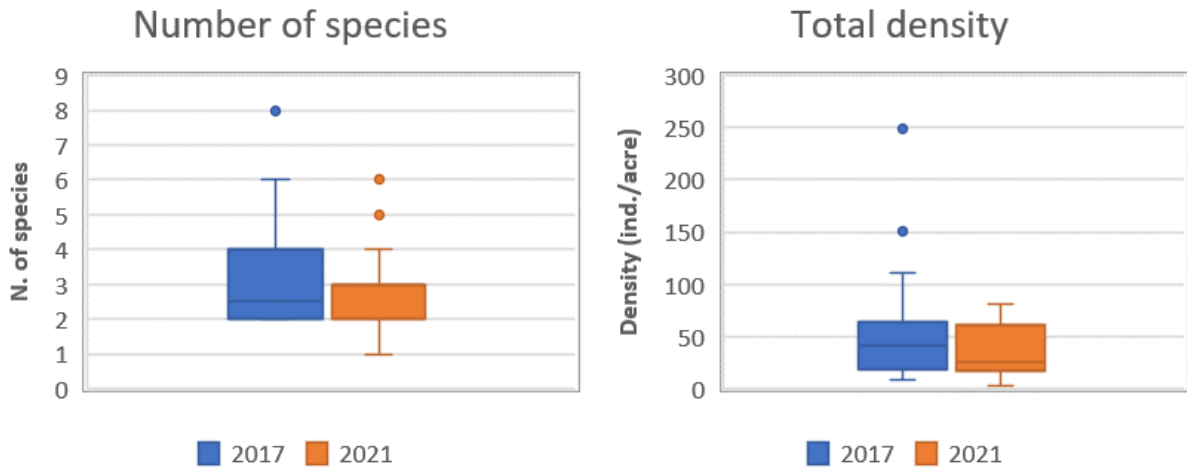
Figure 7. Distribution of species number and total density of all species in 2017 and 2021.

Other fish species caught on sites were alpine bullhead (*Cottus poecilopus*), European bullhead (*Cottus cobio*), greyling, roach (*Rutilus rutilus*), common minnow (*Phoxinus phoxinus*), common bleak (*Alburnus alburnus*), ide (*Leuciscus idus*), pike, Eurasian perch (*Perca fluviatilis*) and burbot (*Lota lota*). The total densities of all fish species, including brown trout were generally lower in 2021 than in 2017 and no significant changes in species number or composition were observable (Figure 7).

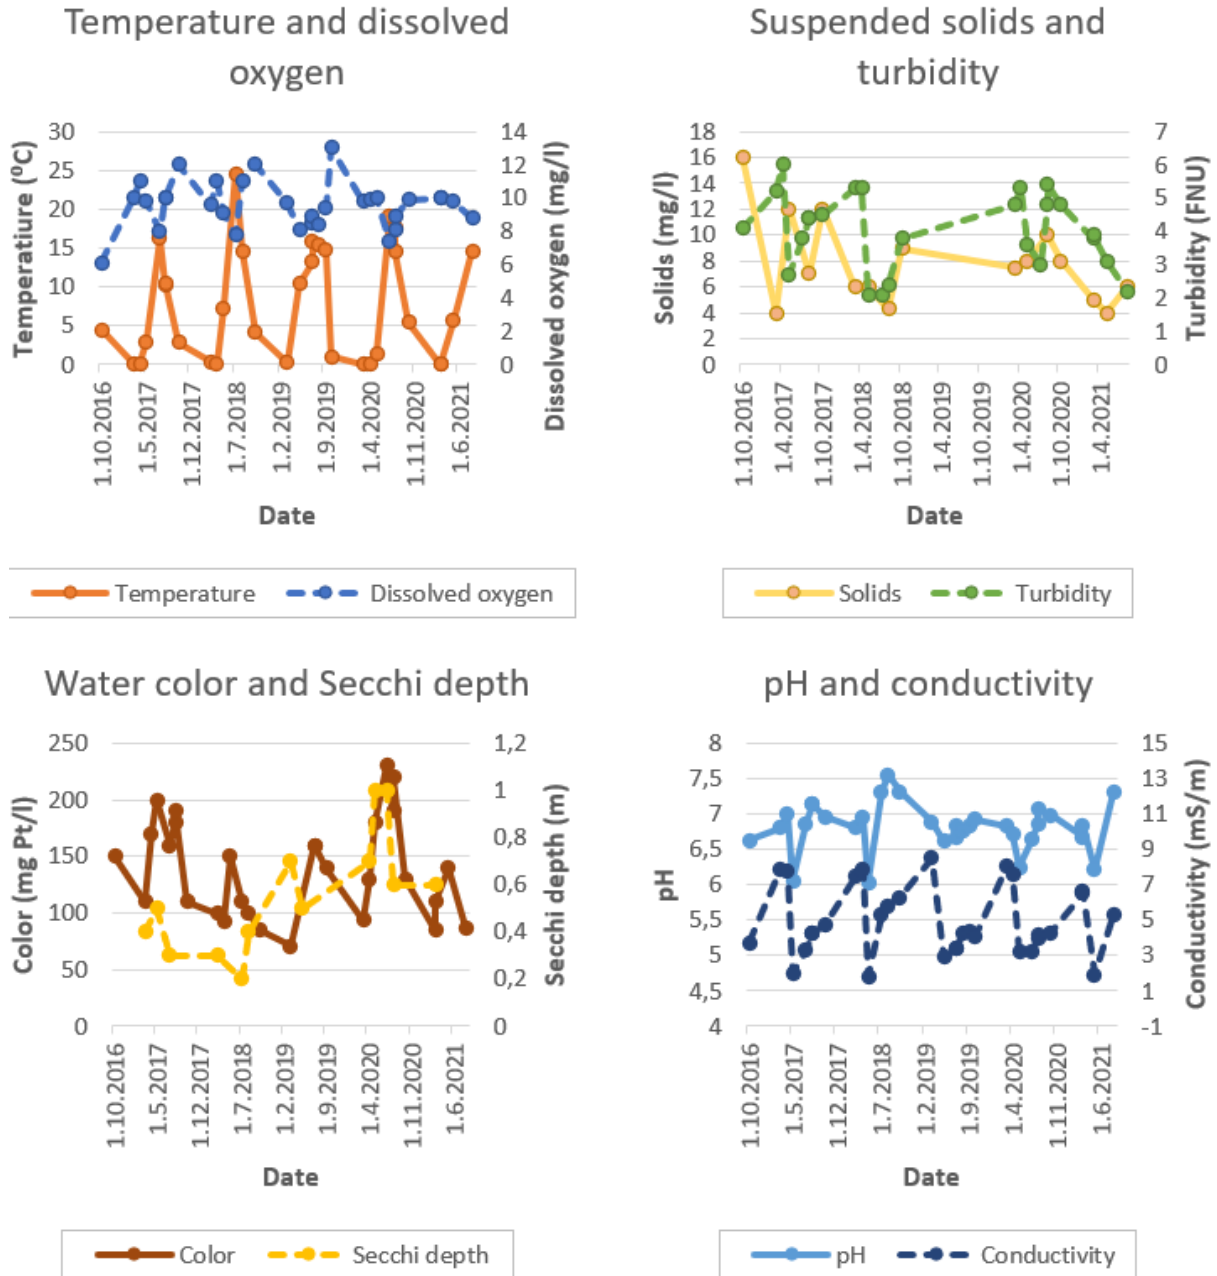
Figure 9. Water quality results from Naamijoki.

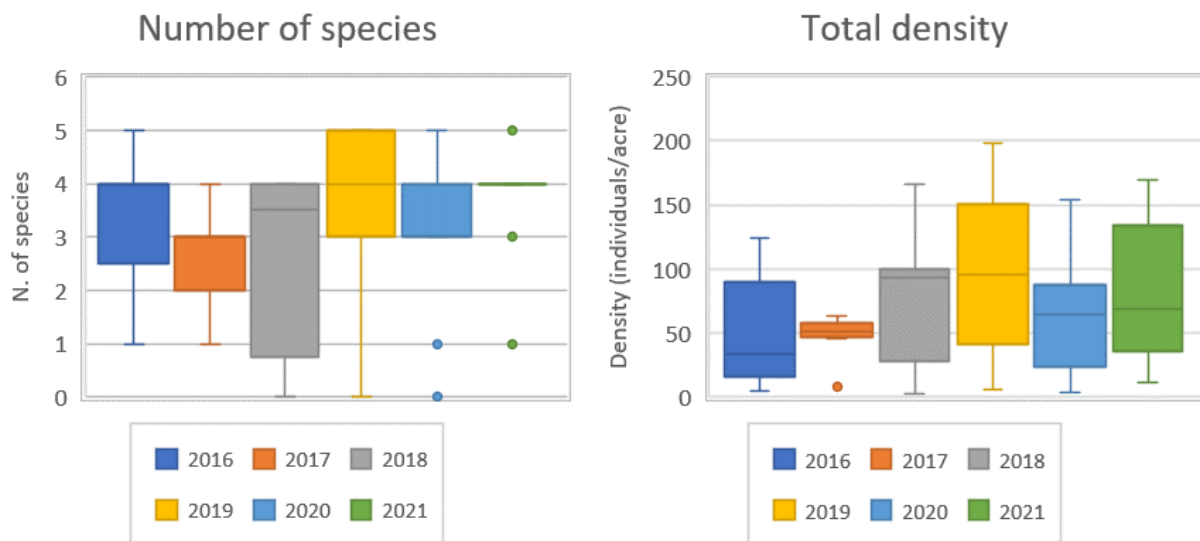
Figure 13. Distribution of species number and total density of all species in 2017 and 2021 in Isojoki.

planeri) were observed in Sillanpäänkoski and Kienokoski. In 2020 adult brook lamprey (*L. planeri*) were observed Sillanpäänkoski and Villamo and in 2021 in Kienokoski. Lamprey species were not observed in any sites during the pre-restoration period (2016–2018). There were no evident changes in species number or total fish density distributions of the sites post-restoration (Figure 13).

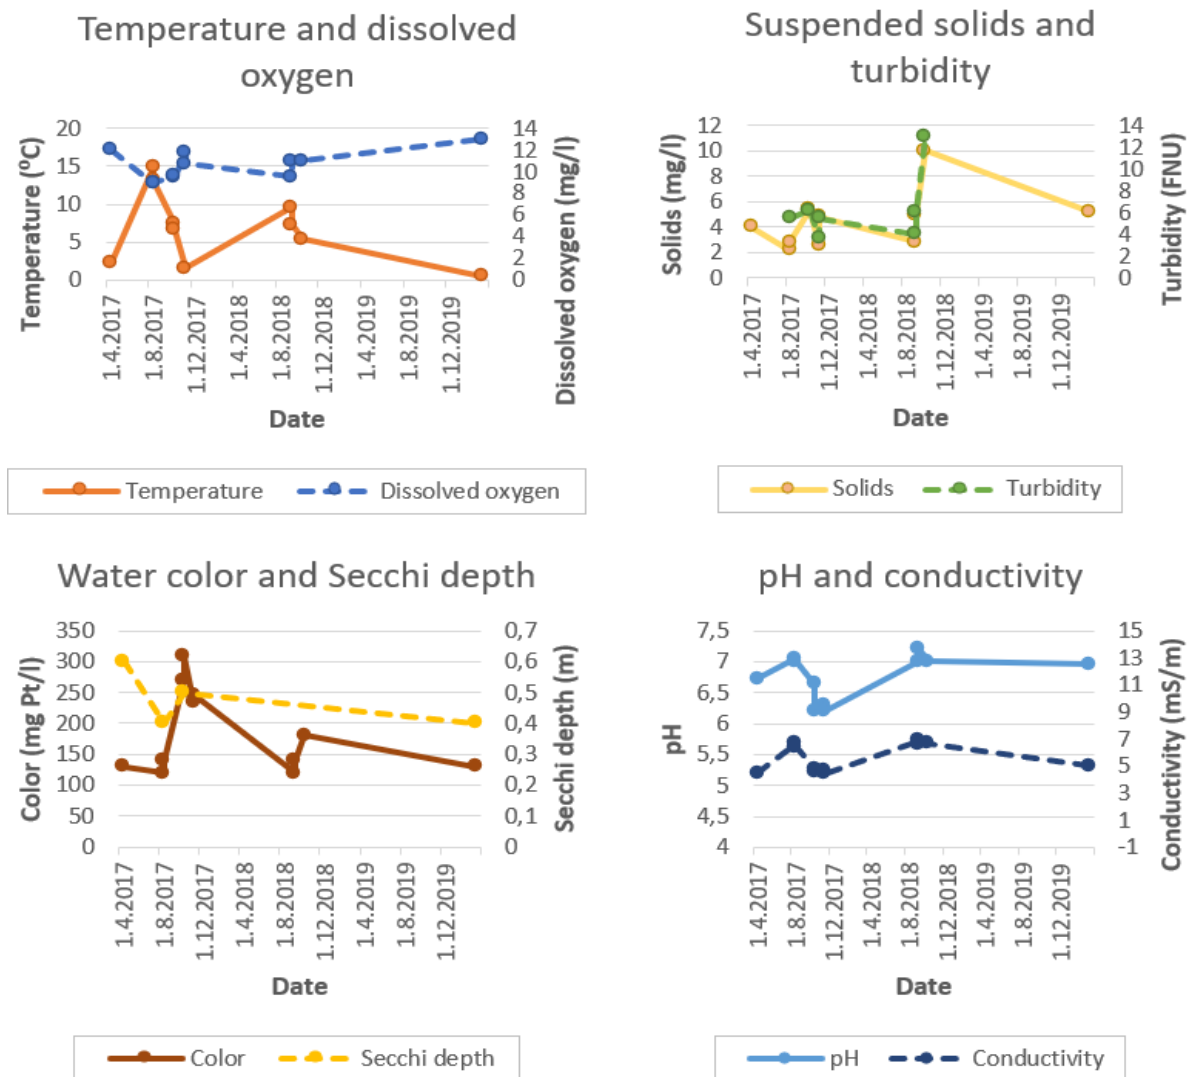
Figure 15. Water quality results for Isojoki.

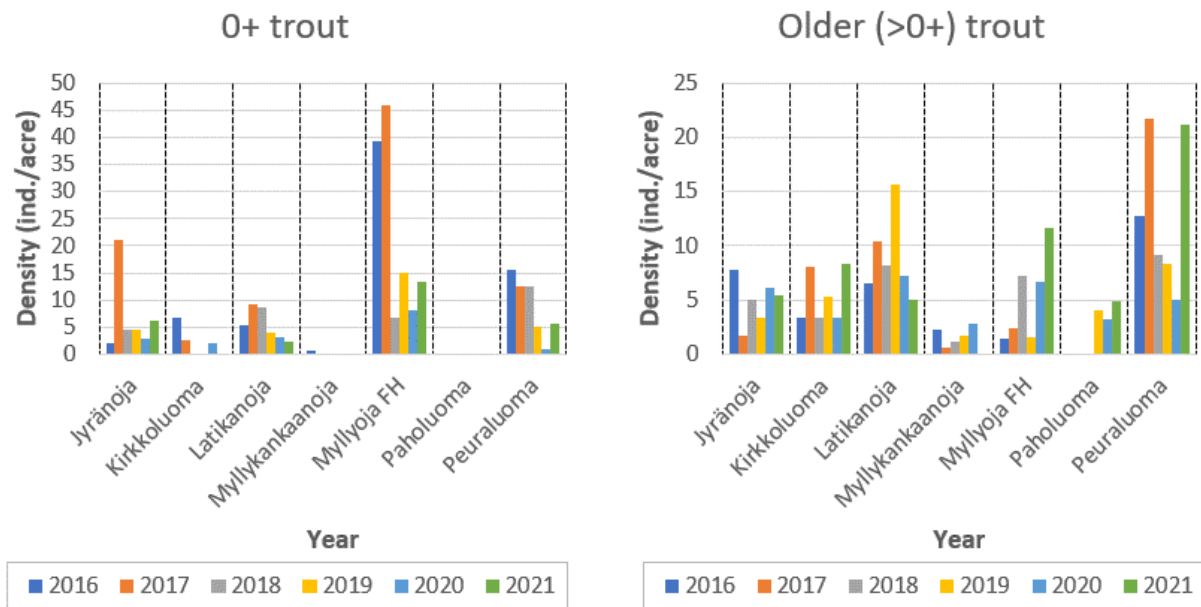
Figure 16. Densities of brown trout in the Karvianjoki monitoring sites during 2016-2021.

Densities of both YOY brown trout and older fish exhibited high inter-annual variation (Figure 16). Mean YOY densities showed some after restorations. This was most evident in Latikanoja, Myllyoja and Peuraluoma. Densities of older trout (>0+) had, on the contrary, increased. Exception to this was Latikanoja, where densities dropped during 2019–2021. Very few other species were observed occasionally on the sites. These included pike, stone loach, burbot and brook lamprey.

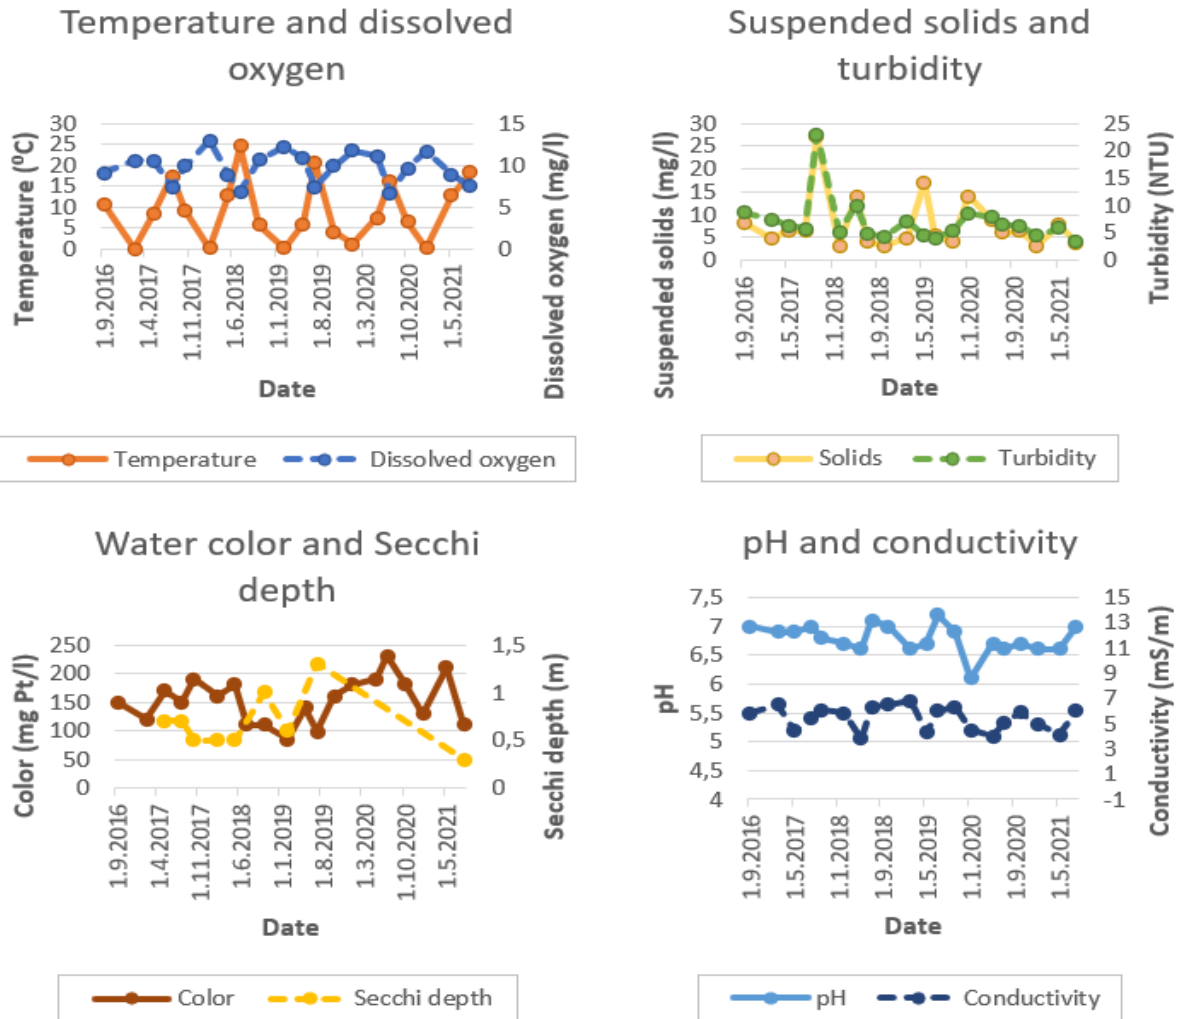
Figure 18. Water quality results for Karvianjoki.

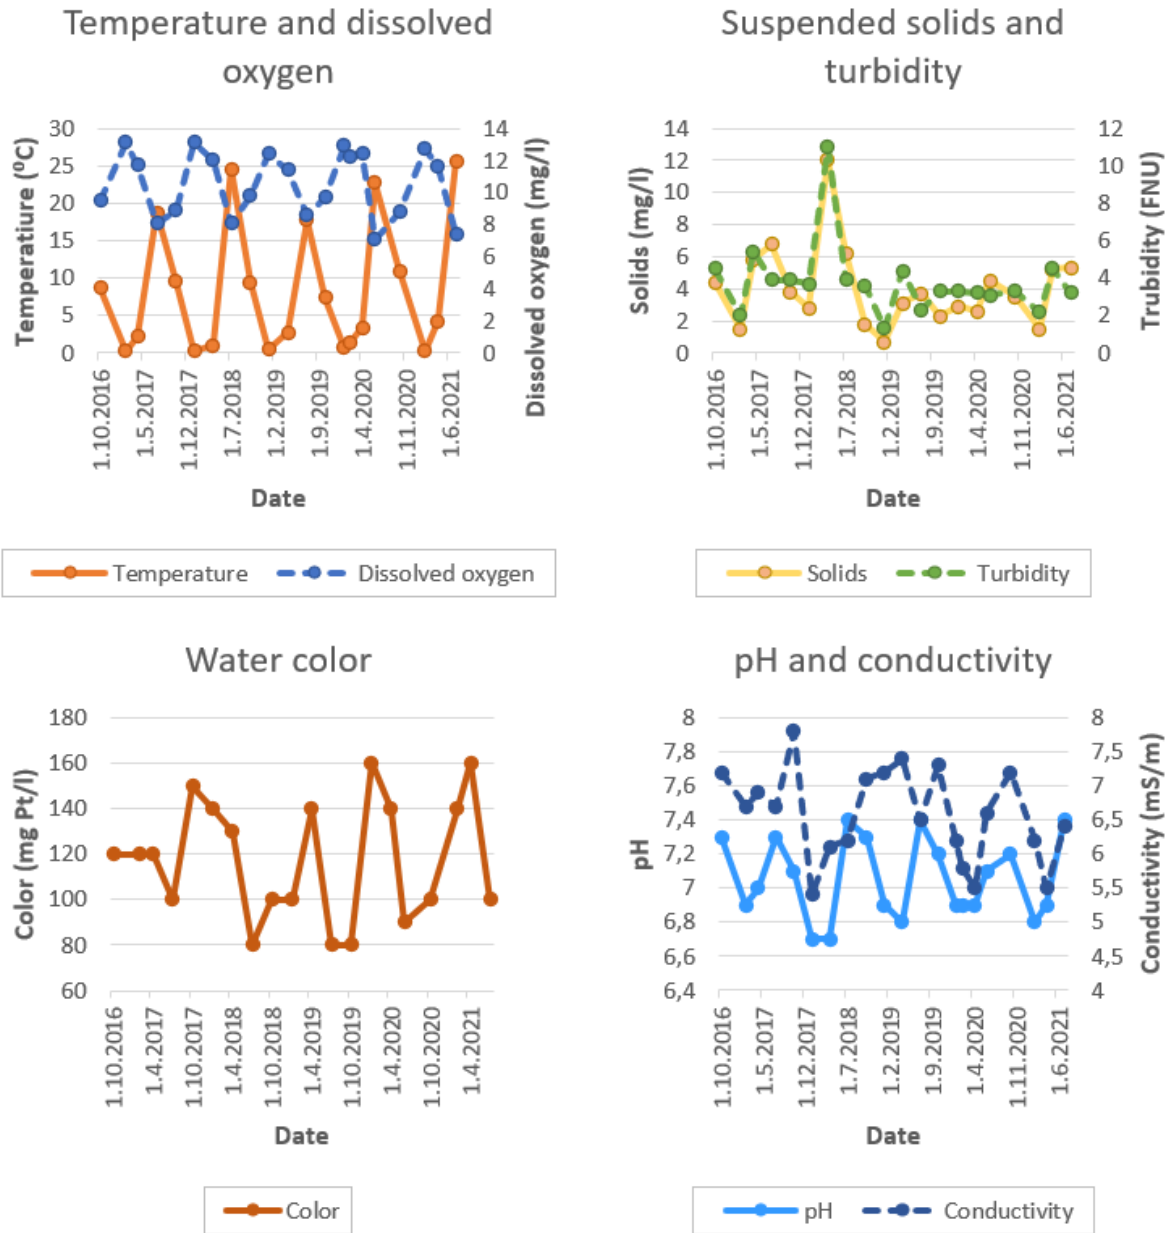
Figure 20. Water quality results for Vanjoki.
